Aging Aircraft 2009

Piper Comanche Stabilator Torque Tube Horn Cracking Study A Type Club Investigation

**International Comanche Society
P. O. Box 1810, Traverse City, MI 49685-1810
(231) 946-3712**

**Hans Neubert, Technical Committee, FAA Liaison
DERT-605393-NM**

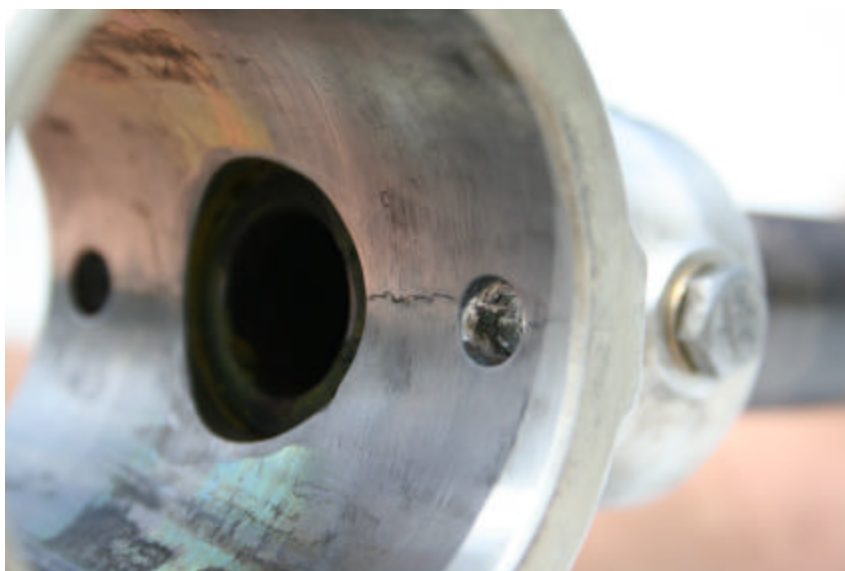
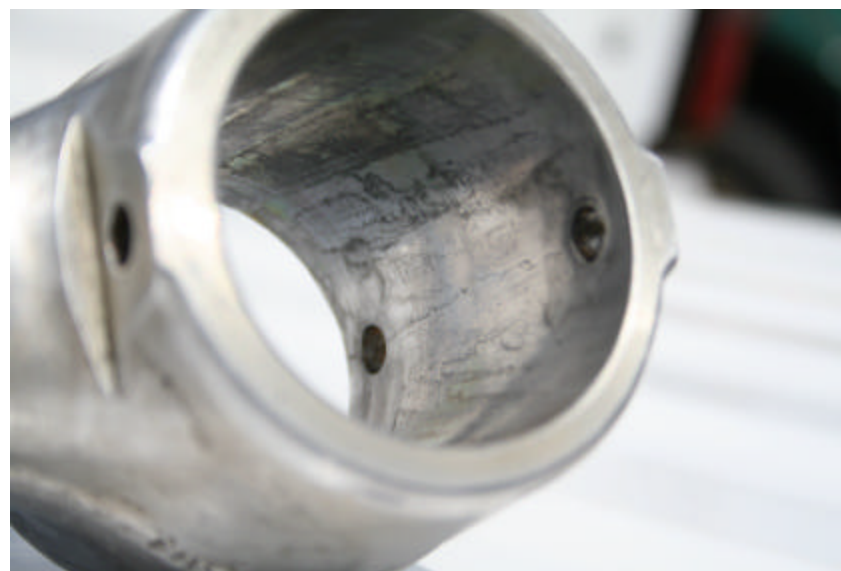
Typical Cracked Torque Tube Horn

NOTES: Cracks observed on singles only. Cracks only observed on early model singles (1958 – 1961). Forward cracks observed at ~3800 hours, while forward and aft cracks observed at ~4900 hours. Later models with higher times have not cracked. No cracks found on Twins or 400 Model singles.

- Common part (P/N 20397-00) used on all models.
- Suspected causes
 - *Vibration in Stabilator system ?*
 - Trim drum play, rod end play, loose control cables
 - Counterbalance weight out of tolerance
 - Stress Concentration at bore intersection
 - Propeller slipstream coupling to stabilator
 - *Metallurgical differences in early/late 2014-T6 forgings ?*
- Significant (30%) GJ torsional torque tube stiffness difference between Singles and Twins ?

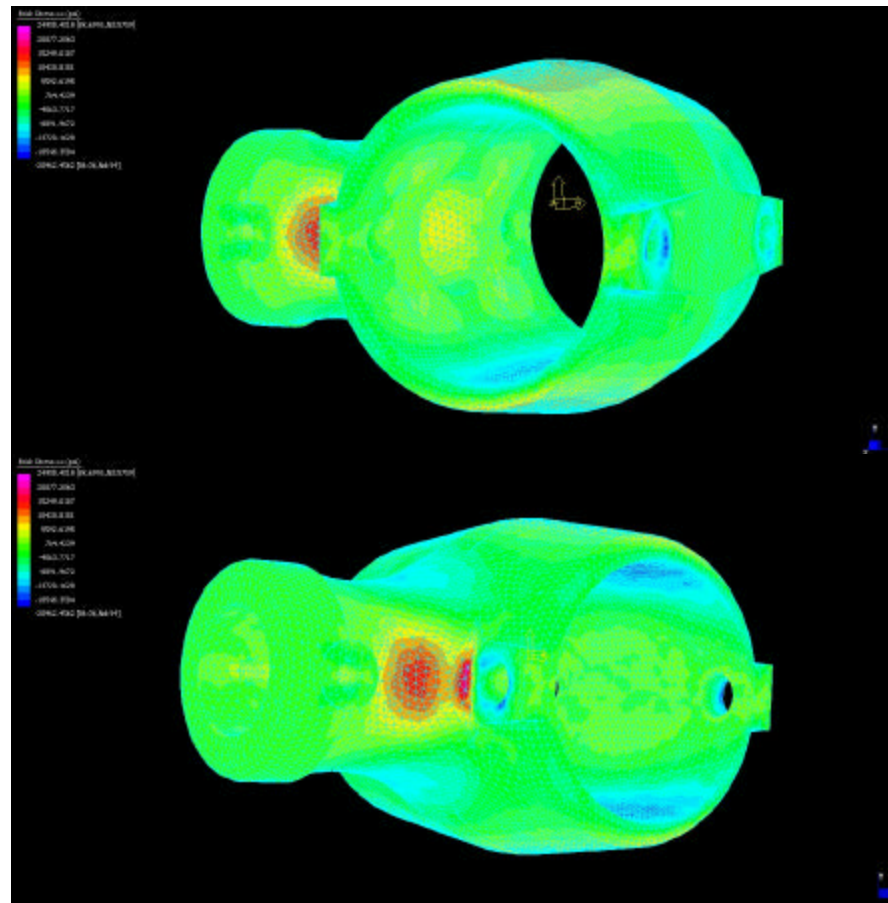
Strand 7 FEA Model – Installed Condition

XX Stresses
24905 psi tension
-20962 psi comp'n

Notes: Installed condition is interference fit with counterbalance arm and bolt pre-load to torque tube.

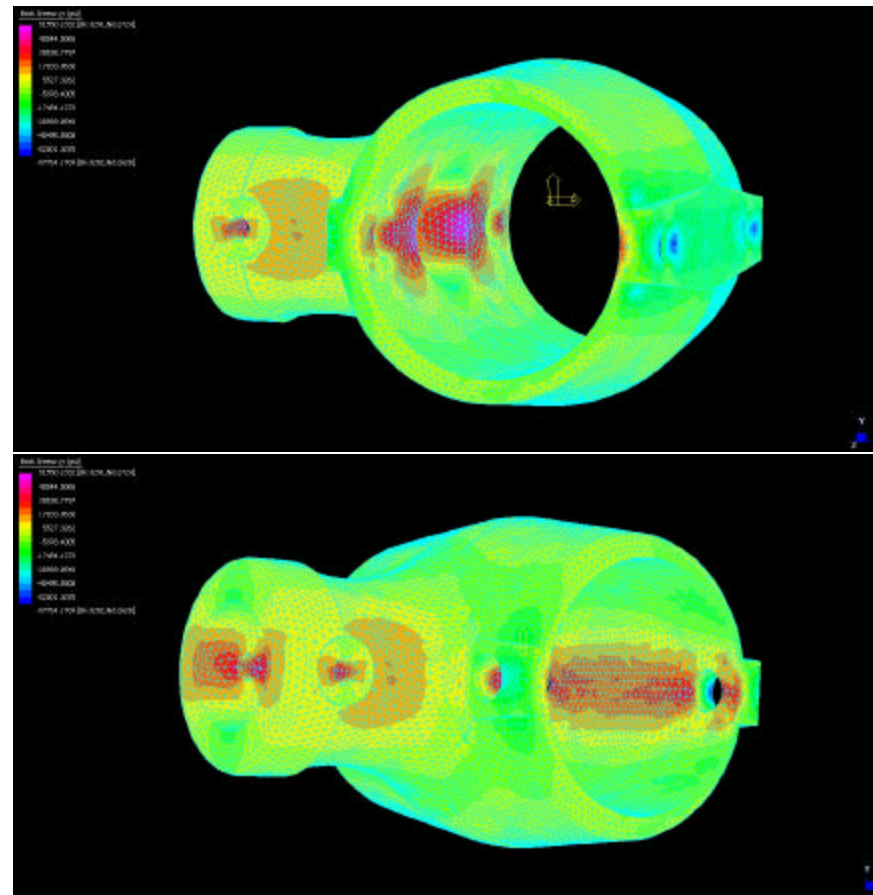
Strand 7 FEA Model – Installed Condition

YY Stresses Max
51550 psi tension
-57754 psi comp'n

Notes: Installed condition is interference fit with counterbalance arm and bolt pre-load to torque tube.

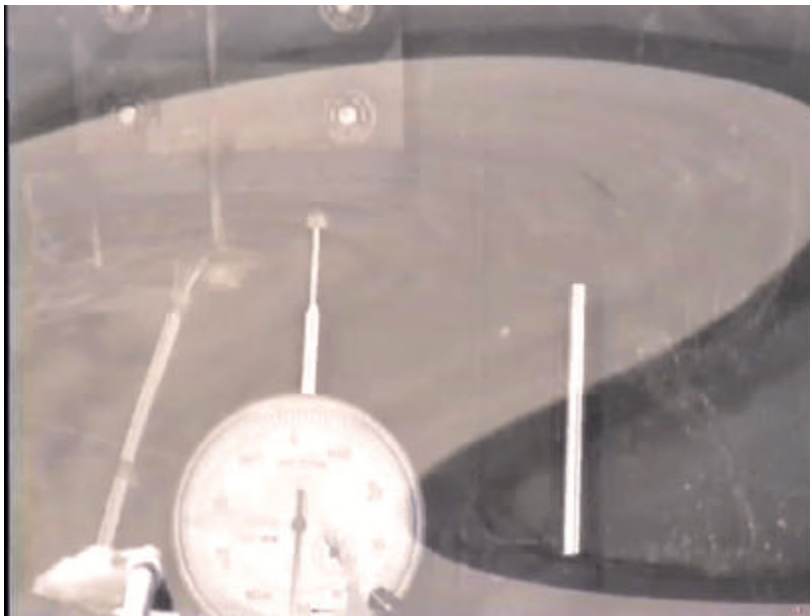
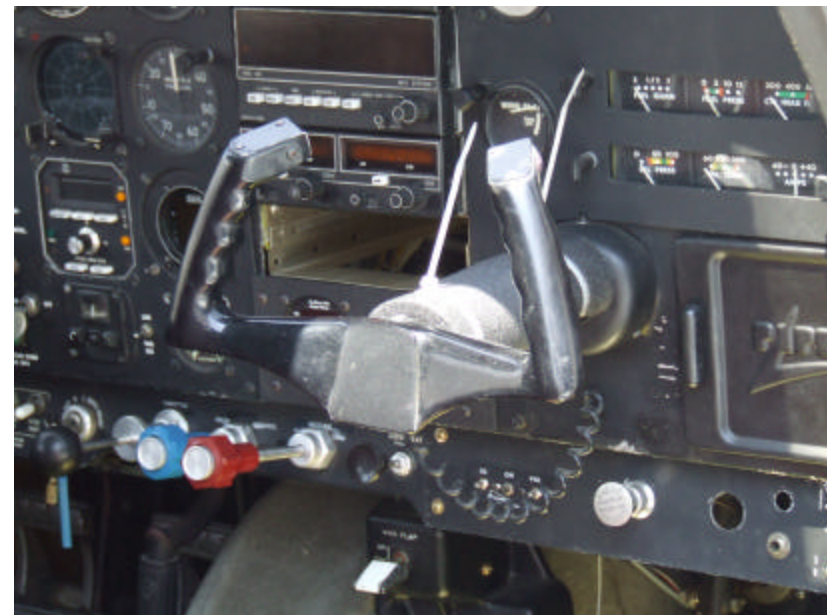
Vibration Measurement with Dial Indicator

Notes: Test aircraft is a 1962 250 single. Stabilator restrained by elevator up-spring and foam pipe insulation ($k \sim 25 \text{ lb/in}$). Dial indicator oscillations impossible to read directly or from video tape. Excursions $\sim .125$ inches.

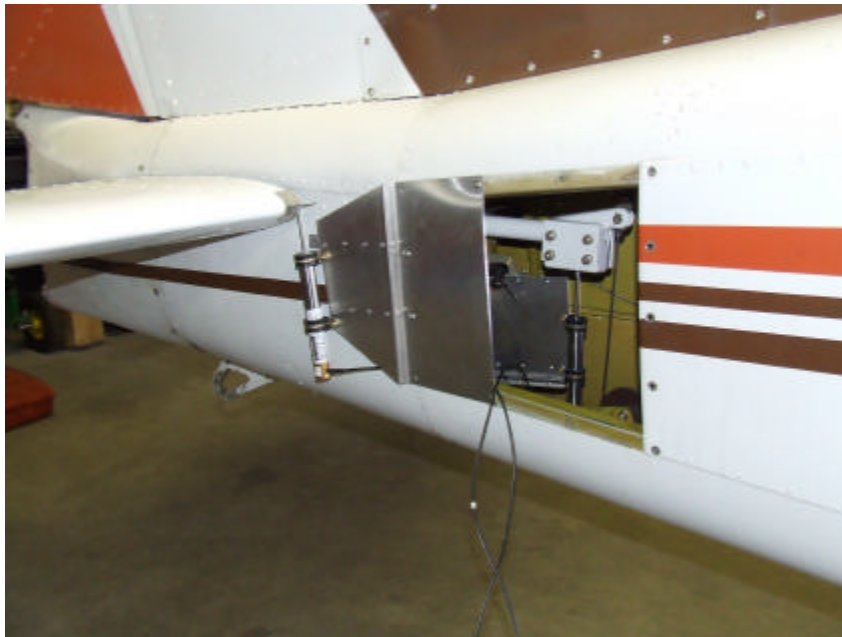
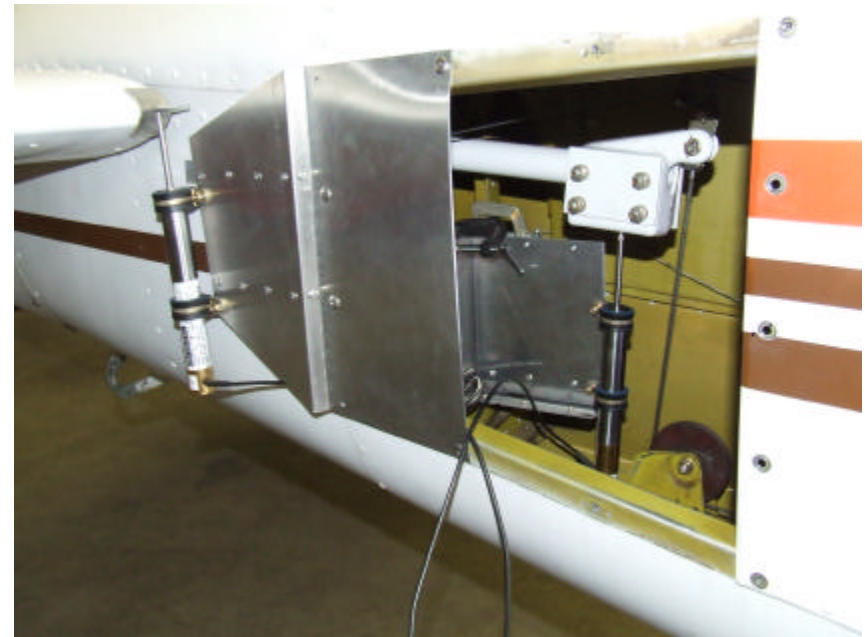
Vibration Measurement with LVDT's

Notes: Brackets fabricated from aluminum sheet to support 5 KHz AC LVDT's measuring stabilator leading edge and counterbalance weight motion. Output to oscilloscope not successful. Data taken from digital displays (~.5 Hz refresh rate).

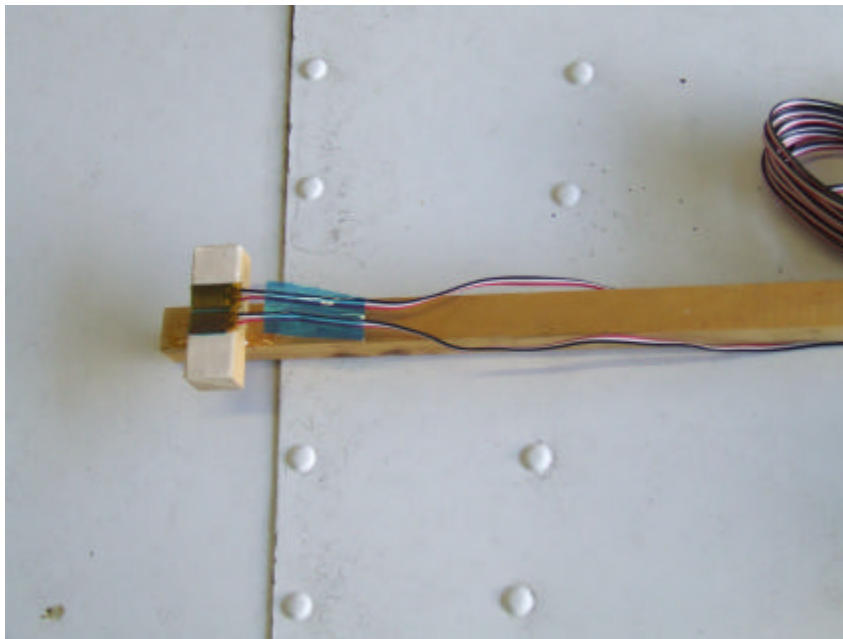
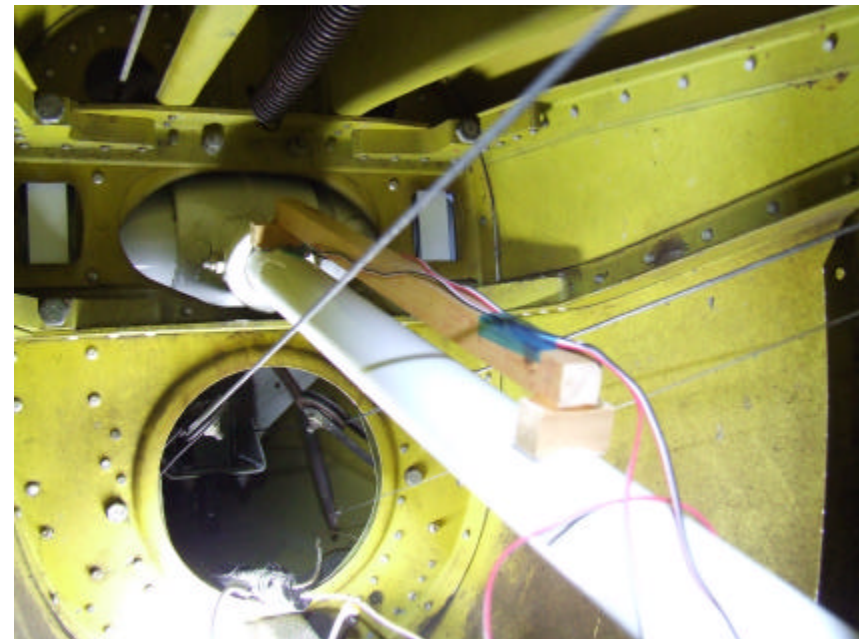
Vibration Measurement with Strain Gages

Notes: Gages installed and calibrated. Gages connected to half-bridge, and ground runs made. Oscilloscope readings unrealistic/unreliable.
