SUMMARY OF CRACKED HORN INFORMATION
7-26-2009
HDN

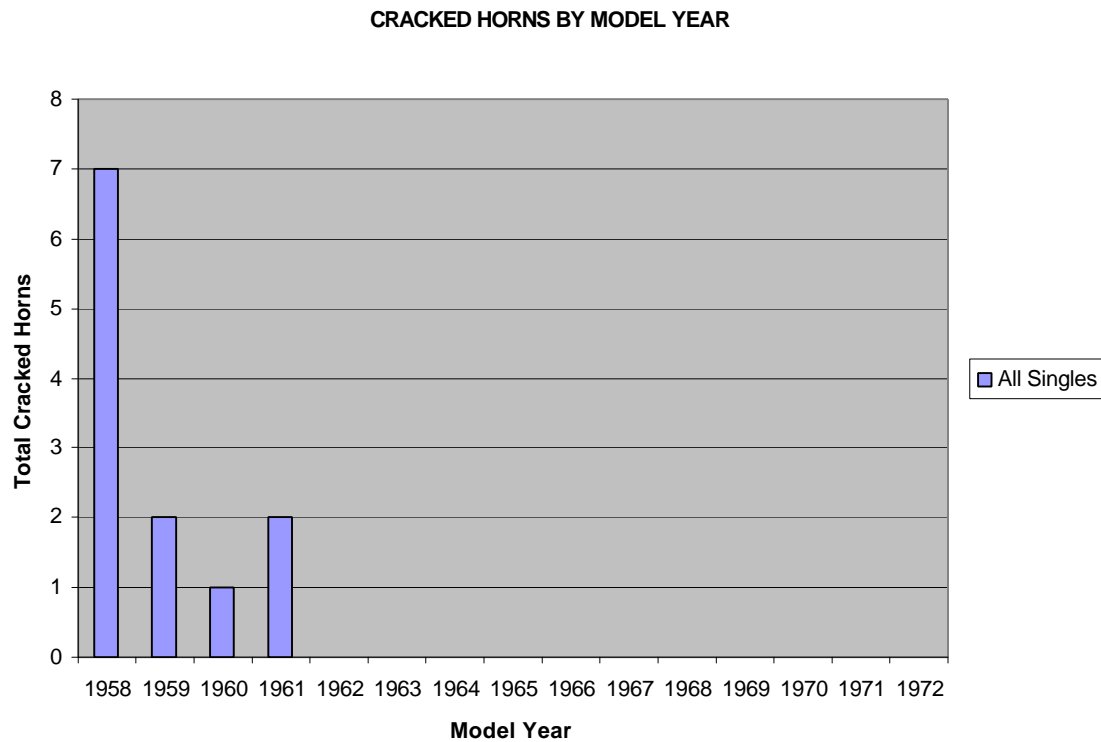
All cracked horns are from the early model singles, produced during 1958 through 1961. ICS believes that Kaiser Aluminum, Erie, PA, produced the known cracked horns. An alternate supplier (date and time uncertain, likely 1962) produced additional horns under the same part number. There are no reports of cracked later model production horns.

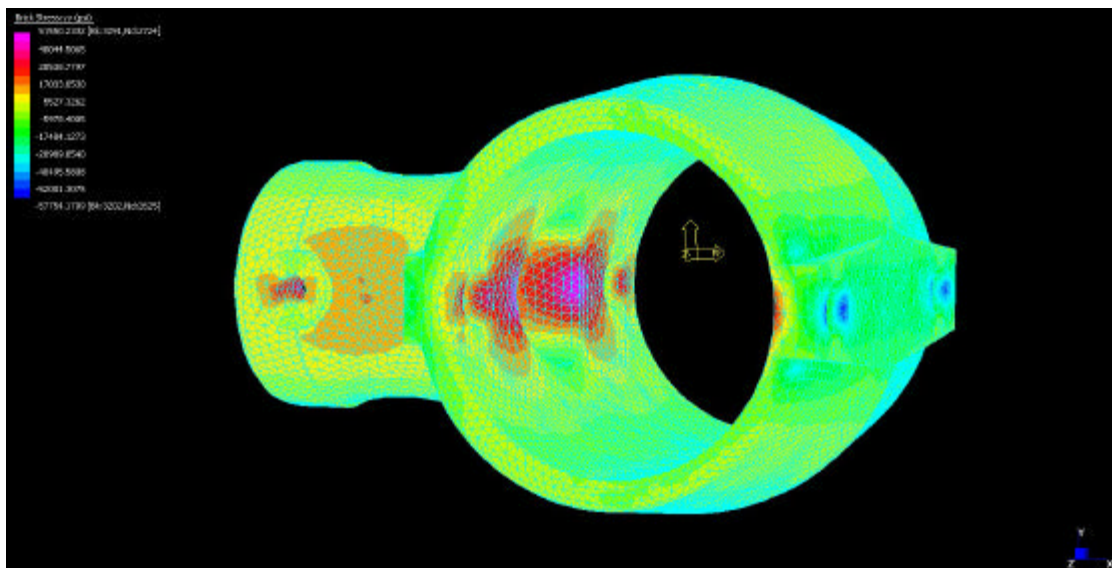
Horn Evaluation by Test and Computation

A 3D solid element finite element model clearly shows that installation stresses caused by the interference fit of the counterbalance arm tube is the principal contributor to horn cracking. The force created by bolt torque is the secondary contributor.

The oval deformation creates a hoop tension stress state that leads to cracking of the rear, interior surface of the horn. This hoop tension stress is also captured by the FEA results.

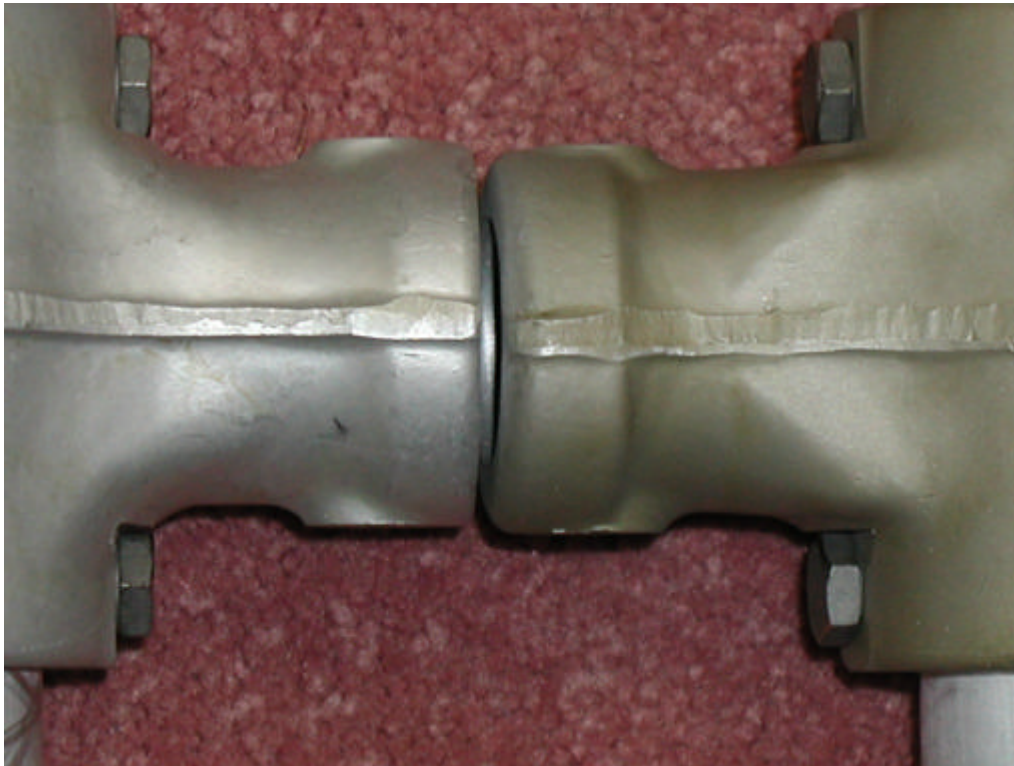
Differentiation Between Early Style and Late Style Horns

The early style horn is shown on the left, while the later style horn is shown on the right. The later style horn has a beefier neck section for the counterbalance arm tube. Determination of horn style can be readily accomplished by visual examination and measurement.
