Tips from Comanche *Flyer* magazines Feb 1973 – Sep 2012

CHAPTER TWO

ENGINE

(EXHAUST SYSTEM, OIL ISSUES, CARBURETION, AIR DOOR, FUEL INJECTION)

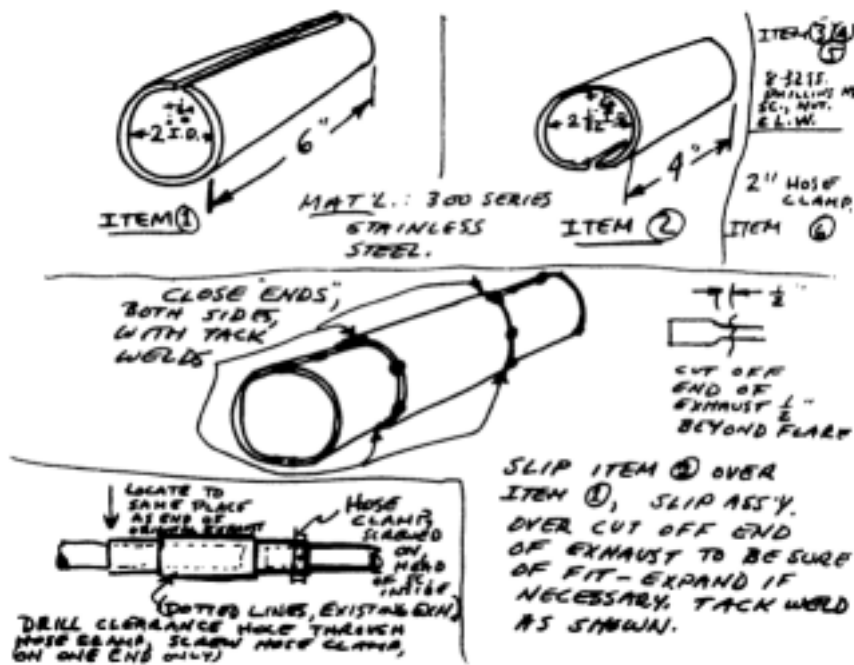
When my 1961 180 was being annualled, the mechanic determined that the crossover pipes on the exhaust system were fused where they touched and as a result, rusting was started. In addition, there was some corrosion caused by fretting in the vicinity of the expansion joint.

After measuring the damaged section, we cut two pieces of 300 series stainless sheet to the dimensions shown in items 1 and 2. Your measurements will depend upon the type fix you are trying to make. I had the two pieces rolled so they would fit inside one another to make a double walled tube. The slots in the two pieces were oriented 180 apart to preclude any gas leak.

The pieces were tack welded since gas leaks were impossible.

A stainless steel hose clamp was fixed over one end of the inner, larger sleeve. A hole was drilled through the clamp, inner sleeve and exhaust tube.

A stainless steel screw of proper size was fitted to a long screwdriver with some 'gunk' to and carefully worked from the inside out. I did it this way since I thought that I could better determine if it was starting to loosen. I could also mash the threads to further insure integrity. This fix worked so well on the one pipe that this year, we did it to the other pipe.

The fix is very professional looking and the stainless is still nice and bright – a sharp contrast to the exhaust system.

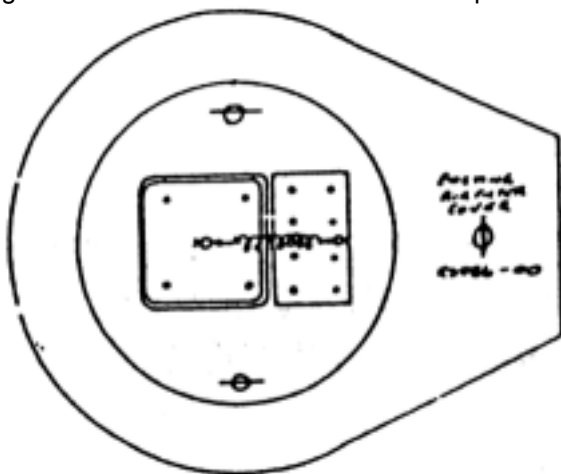
A member has developed a modification for removing the alternate air door from the engine high vibration area to the air filter cover where it is also more readily available for pre-flight inspection in the PA-30 Twin Comanche.

The following drawing indicates the new location. A copy of the complete drawing as approved by the Australian government is available from ICS Headquarters.

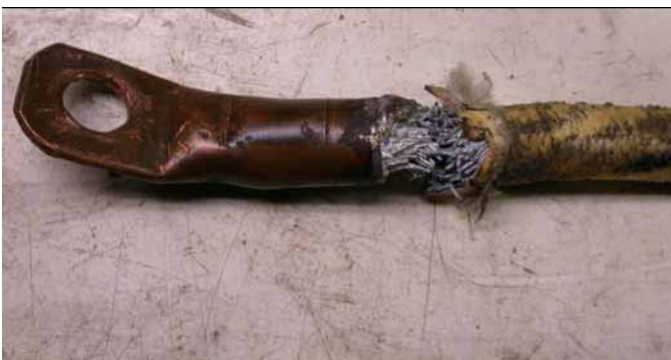
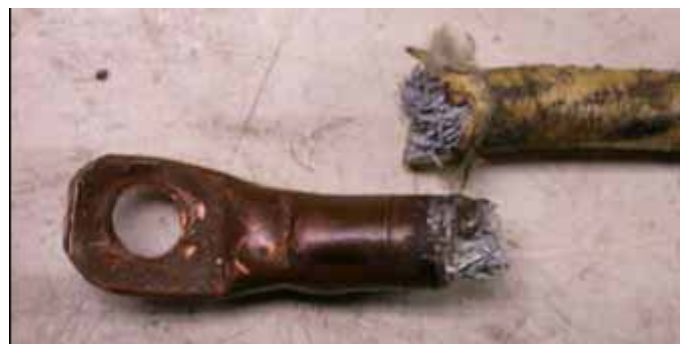
Last thing is something that we found when we were troubleshooting a slow starter. This is just an example of what looks new or in good condition – but isn't. Troubleshooting is very easy when you understand the system, but this was too simple. We removed the cowling and proceeded to look at the starter wire. I noticed a little corrosion on the terminal end. While I was removing the terminal end, it broke off. The wire broke in half. The old aluminium wire had broken down and was turning to powder. This airplane had only 1,200 hours on it but was almost 40 years old. Time to replace the cables.

A sure sign that it's time to replace the starter cable.

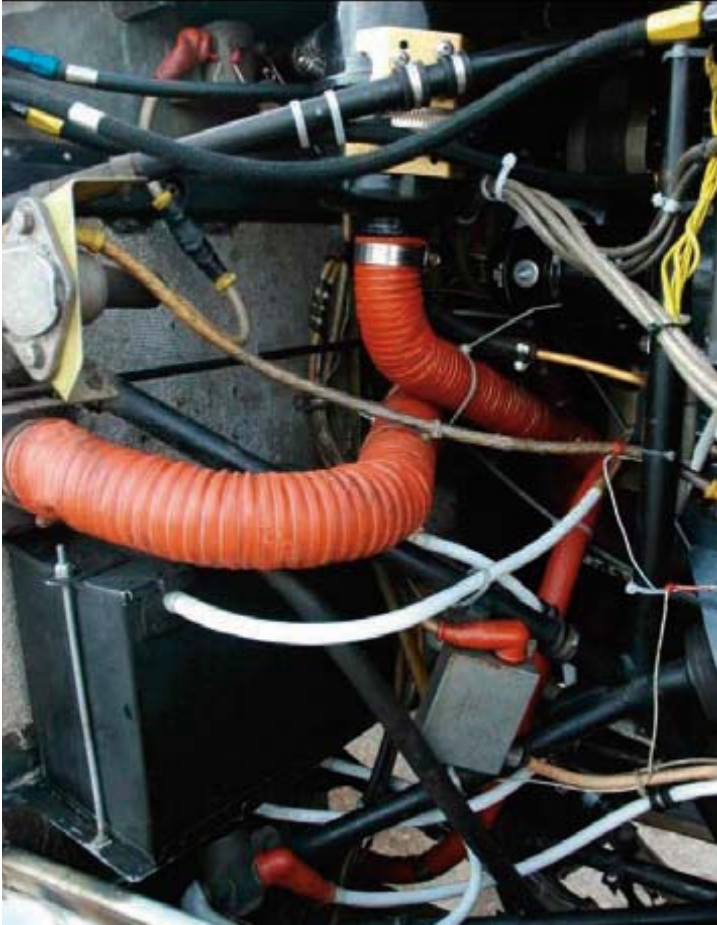
Battery box with the Bogert "Low Loss" copper cables.

The Bogert "Low Loss" cables have at least 55% greater capacity than those specified in the service bulletin and it sure shows. Our trusty 180 gave us many more years of reliable service and never again gave us any problems or issues when starting whether hot or cold.

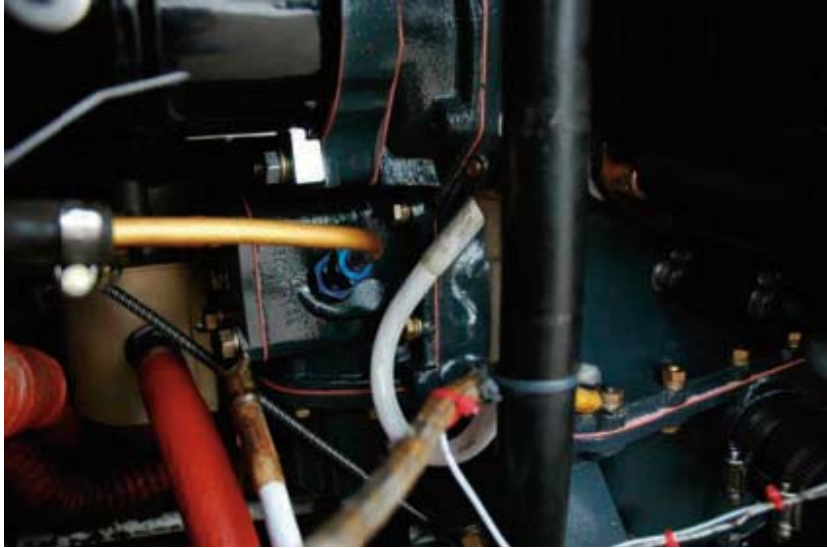
Engine to frame copper ground cable included in the Bogert kit.

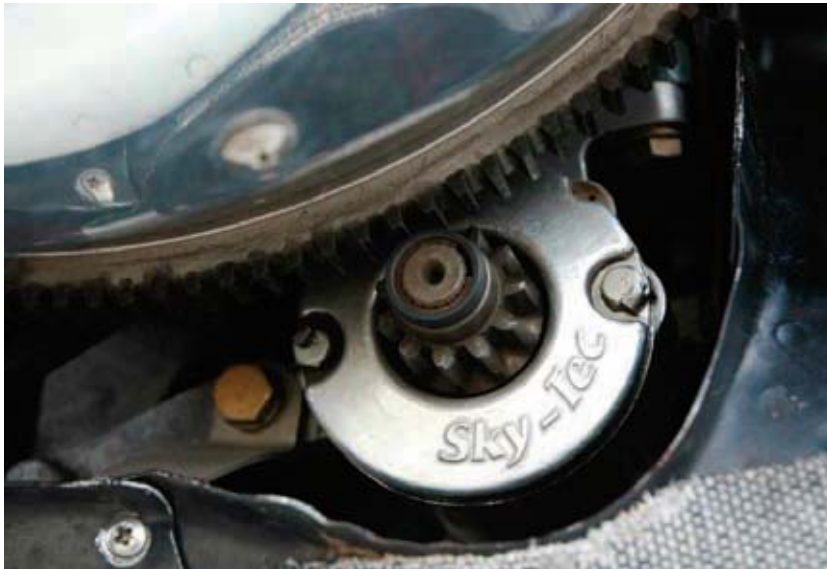
Front view of the Sky-Tec NL lightweight high torque starter

Many years later when I purchased my current Comanche, which just happens to be the first 260B model ever produced, the first thing I asked the previous owner was if it had the original starter. It did, but not for long. Prior to picking up the airplane, I had the local shop install a new Sky-Tec High-Torque Inline NL model.
