Tips from Comanche *Flyer* magazines Feb 1973 – Sep 2012

CHAPTER TWO

ENGINE

(EXHAUST SYSTEM, OIL ISSUES, CARBURETION, AIR DOOR, FUEL INJECTION)

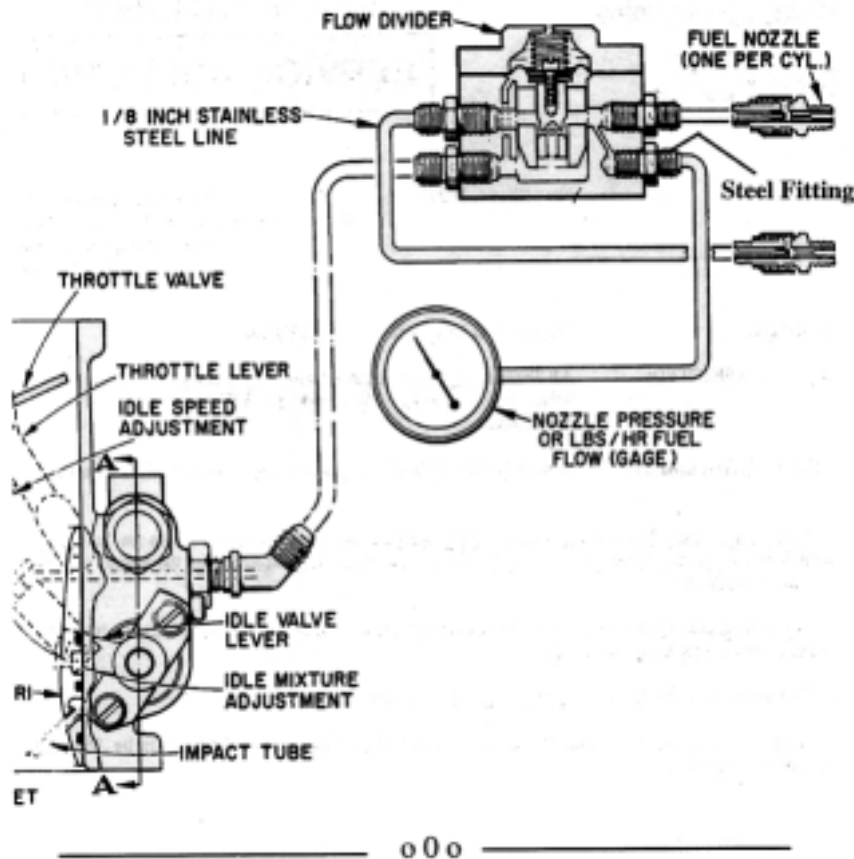
He and his mechanic found the answer to the problem. The fittings coming out of the flow divider are all brass except the one going to the fuel flow gauge and this is steel. It is also a restrictor. See the drawing. They found this fitting was badly rusted on the inside and happens to be next to the fitting going to the #3 cylinder. It is obvious that the rust particles breaking loose from the fitting found their way to the #3 nozzle. I have sent him two treated (chrome plated) fittings which should not rust.

In the fuel injected singles and twins, besides this restrictor fitting, a stainless steel wire is inside the portion of the fuel flow gauge line from the flow divider to the engine baffling. This must not be removed as it is an additional restrictor. I thank Dr. Hayward for this information as it should be very helpful to the members.

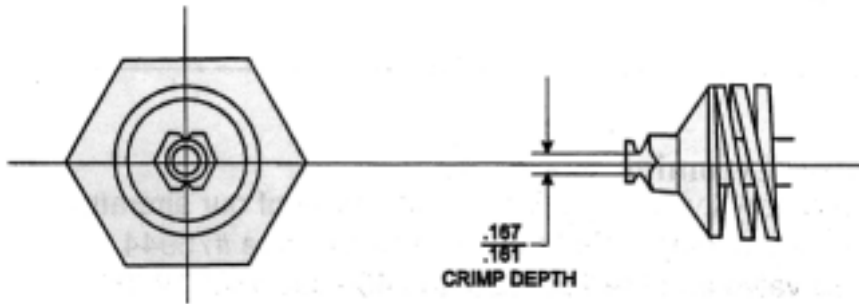
Step 1 is the dimensional inspection of the crimp nut. The crimp depth on the nut must be .161 – .167 as shown in Figure 1.

If the thermostatic bypass valve does not meet either step of the inspection, it must be replaced immediately.

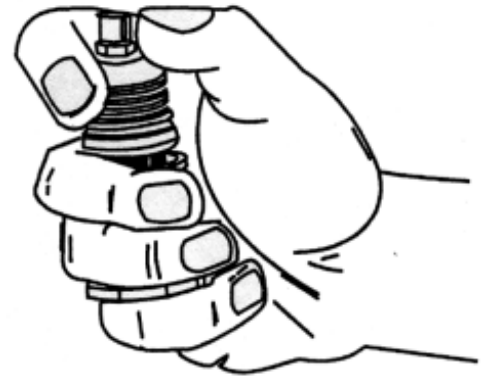
Figure 2.

Separate the seat and retaining nut by holding the valve assembly in one hand and compressing the valve spring with the forefinger and thumb. (See Figure 2.) With the seat and nut separated, grasp the crimp nut with the other hand and attempt to move it. The crimp nut must not move.
